# Manhole Inspection Summary

Manhole # S25UU1006MH

Insp Date: **5/3/07 3:42 PM**

**Location** Address: **5100 ROLAND AVE**

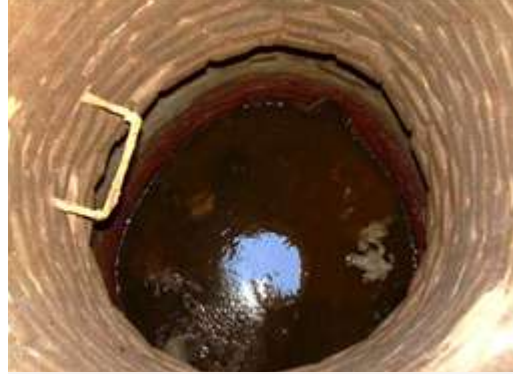
Top View

Corroded and missing steps. Evidence of surcharge - Channel debris.

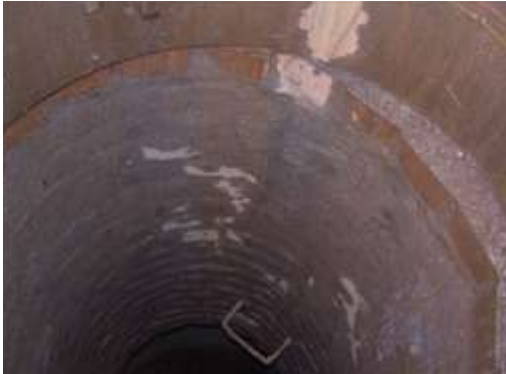
Defect

Frame leaks. Frame offset. Adjustment and Corbel infiltration. Corroded and missing steps.

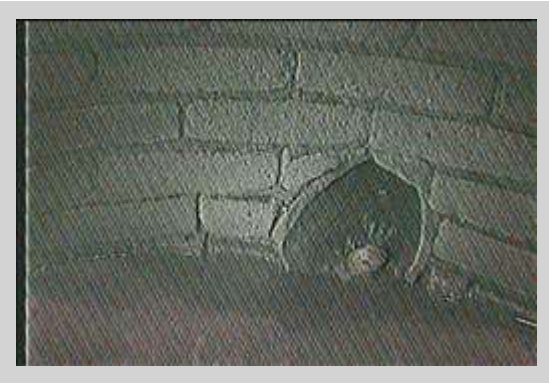
### 8 in. Circular Gravity Sewer Pipe Out @ 12 O'Clock

Deposits: ☐ None ☒ **Mud** ☐ Sludge ☒ **Debris** ☐ Grease

Silt Depth: **0** (in.) Deposits Extent: **Light**

Infiltration: **Evidence** Pipe Seal Cond: **Broken**

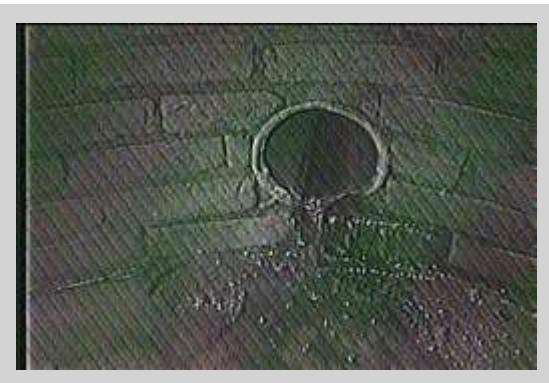
### 8 in. Circular Gravity Sewer Pipe In @ 3 O'Clock

Infiltration: **Evidence** Pipe Seal Cond: **Broken**

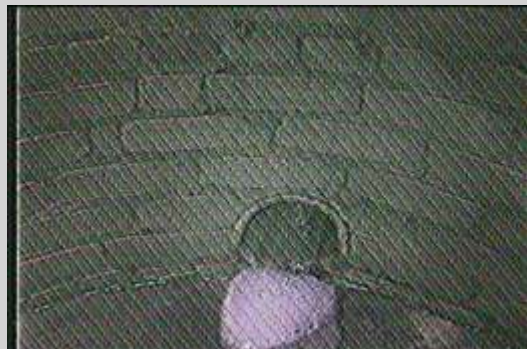
Pipe In @ 6 O'Clock

Infiltration: **Evidence**
